**RESTAURĒTIE
KULTŪRAS
PIEMINEKĻI
LATVIJĀ
2017**

**RESTORED
CULTURAL
MONUMENTS
IN LATVIA**

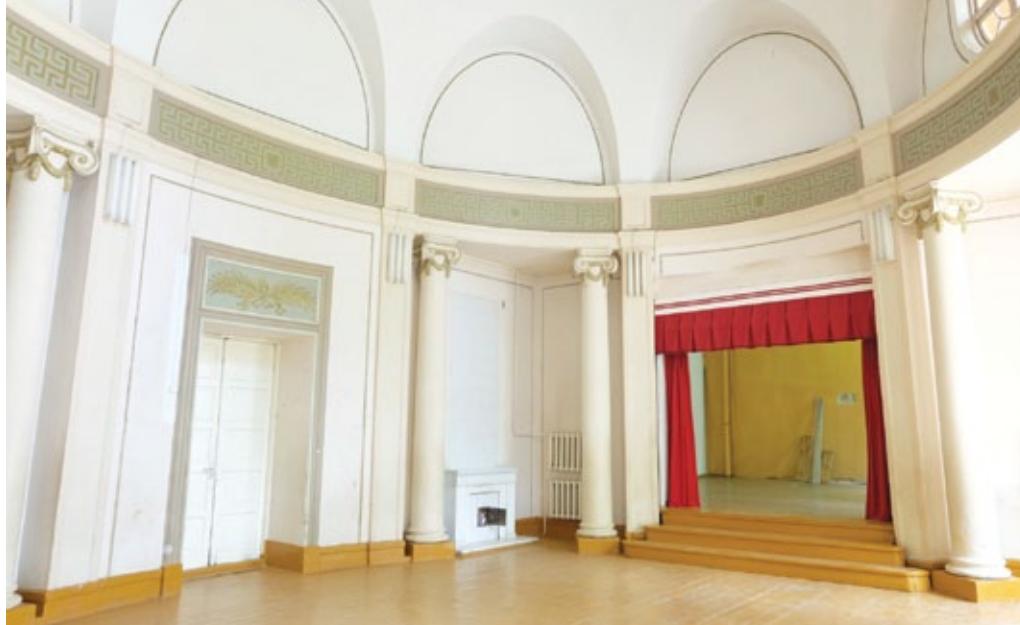
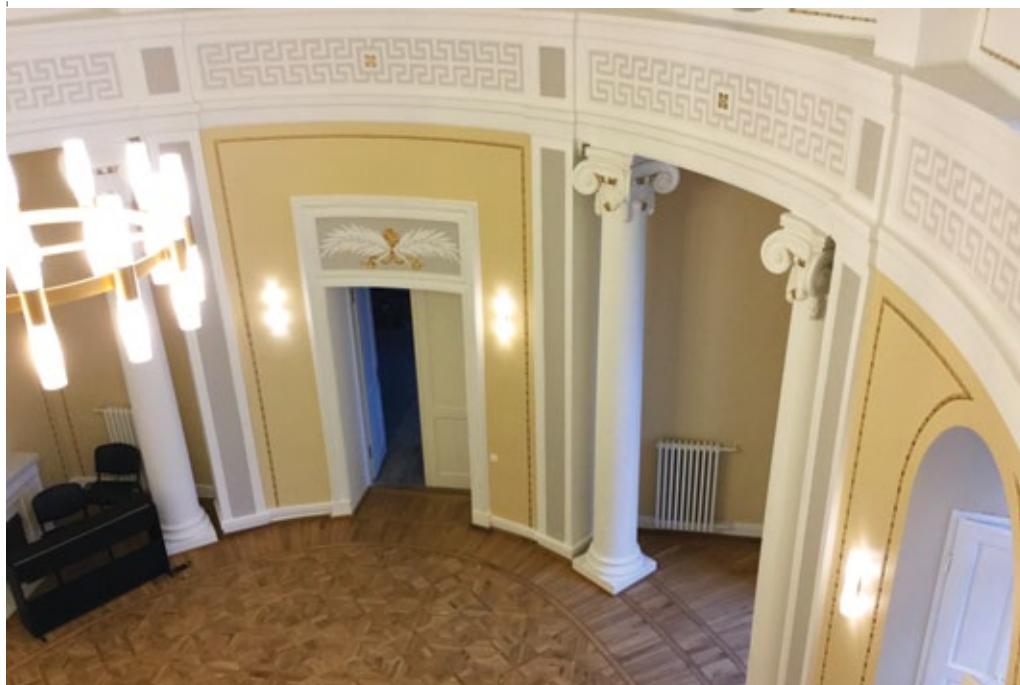
The building has been permanently occupied and is continuously maintained. The elements of the historical interior finish and timber parts have been partly preserved, although covered by thick layers of paint that has been improperly applied during the multiple repairs. Consequently, it was concluded that the visual, as well as the technical condition of the premises do not comply with modern standards. Moreover, after a stage was built and an opening in the wall was made, the arrangement of the hall was changed.

In the course of the restoration, the original arrangement of the hall was restored. The following elements were restored: fireplaces, painting and construction timber details and interior finishes (pillars, portals, decorative meander border). A new floor was installed based on the historical examples.

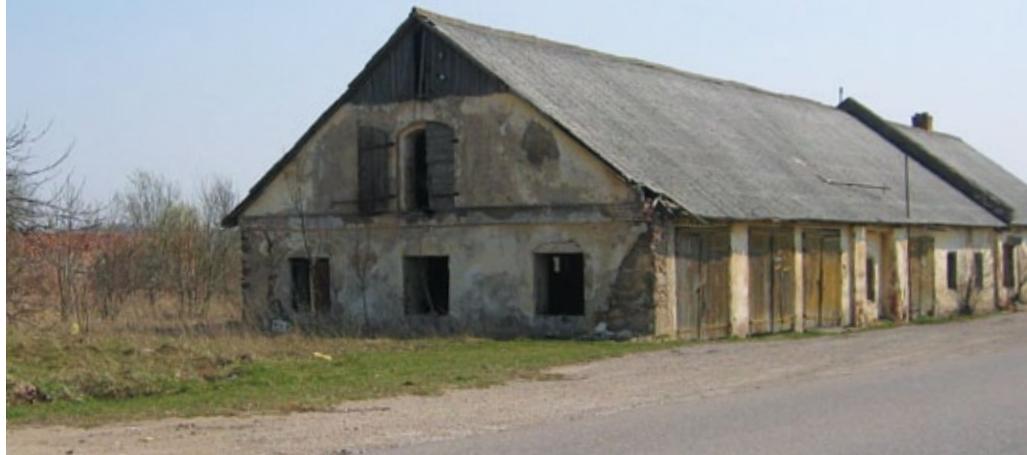
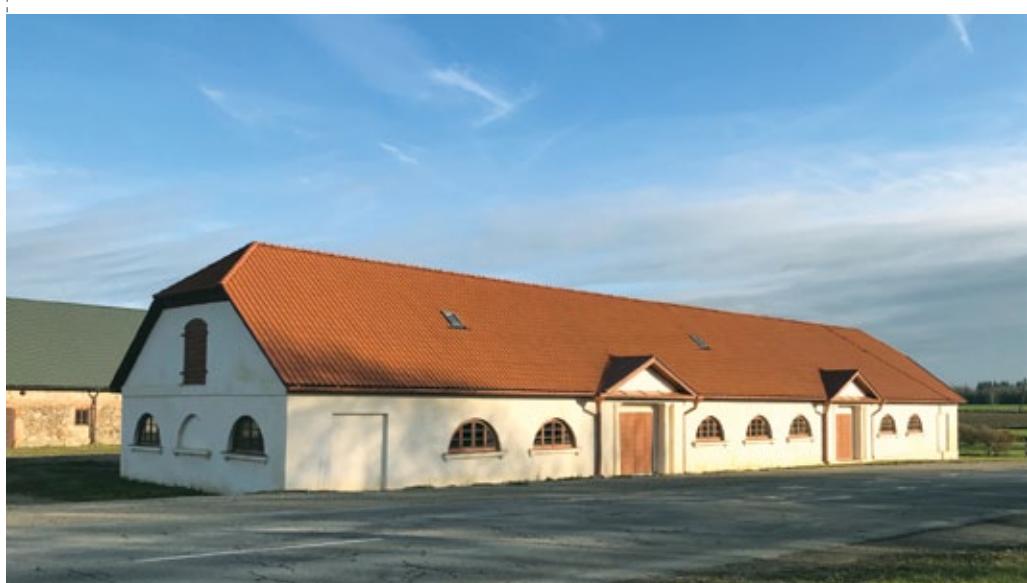
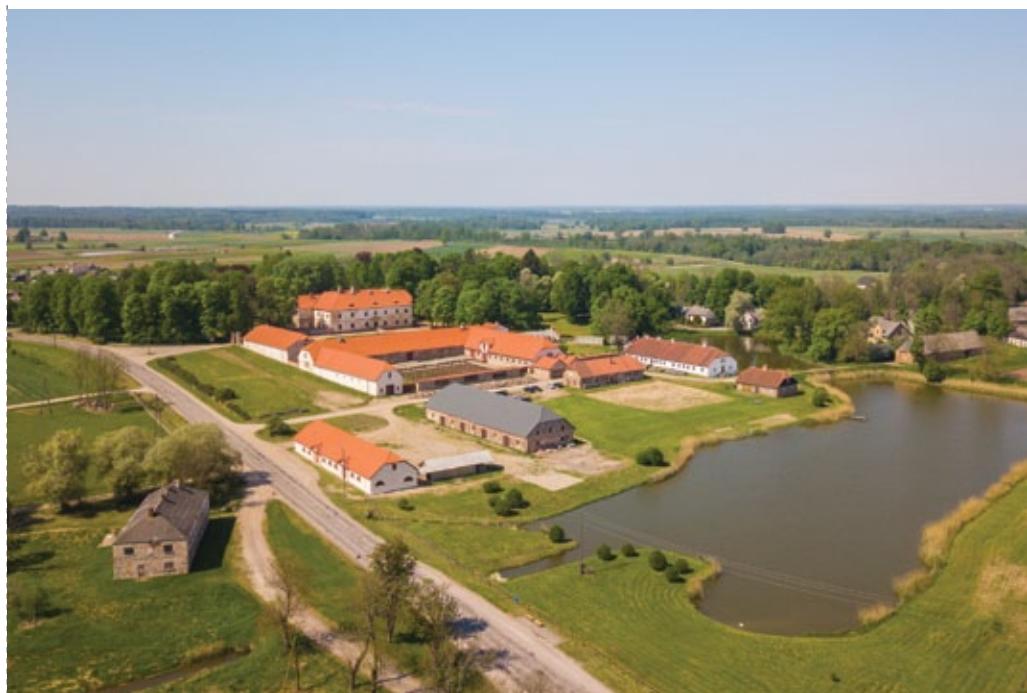
Although the Nurmuiža Manor is one of the oldest manors in Latvia and the arrangement of the complex has changed significantly over time, the construction volume of the manor house has preserved the historical shapes and architectural formations dated to the 17th century. Other developments on the territory of the manor are dated back to the 18th century and the early 19th century. During the soviet times, the Nurmuiža pub building was transformed into a mechanical workshop. During the conservation process, the facades and roof were restored, the stone wall was fixed ensuring its load bearing capacity by rebuilding the lost and eroded patches of the construction. A reinforced concrete belt and a system of buttresses were developed to ensure the structural stability of the stone wall construction. The plastered surface of the facades was preserved. The roof was renovated in conformity with its authentic geometry and structure. The entrance door pediments were refurbished, whereas the window, door and gate leafs were made based on the historical samples. At the end of the pub building, a timber frame shed was reconstructed with staggered cladding and a wood shingle roof.

Konservācijas procesā veikta fasāžu un jumta restaurācija, atjaunota mūra konstrukcijas nestspēja, pārmūrējot zudušos un erodējušos konstrukcijas fragmentus. Mūra konstrukcijas struktūralās noturības nodrošināšanai izveidota dzelzsbetona josla un konstruktīvo kontrforsu sistēma. Fasādēm saglabāta apmesta mūra virsma. Jumts atjaunots atbilstoši tā autentiskai ģeometrijai un konstruktīvai struktūrai. Atjaunoti ieejas durvju frontoni un izgatavotas vēsturiskam paraugam atbilstošas logu, durvju un vārtu vērtnes. Kroga ēkas galā atjaunots šķūnis koka karkasa konstrukcijā ar trīnīti kārtotu dēļu apšūvumu un koka skaidu jumtu.

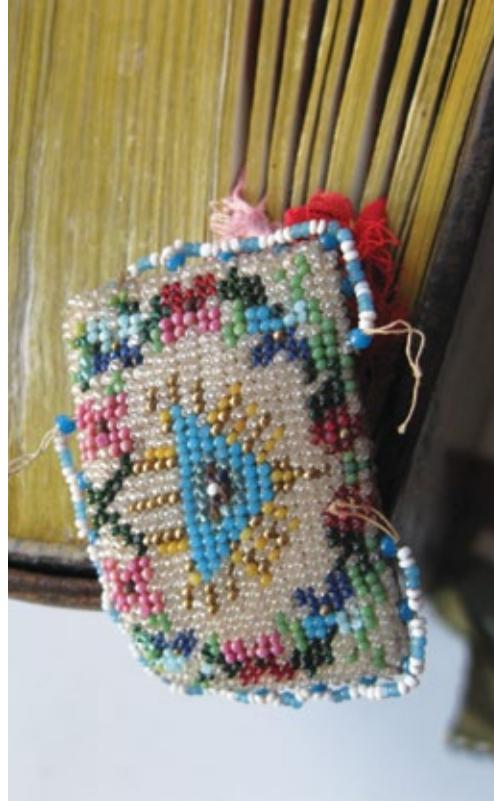
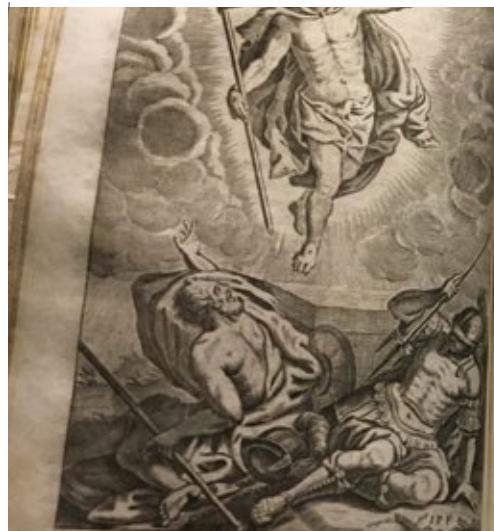
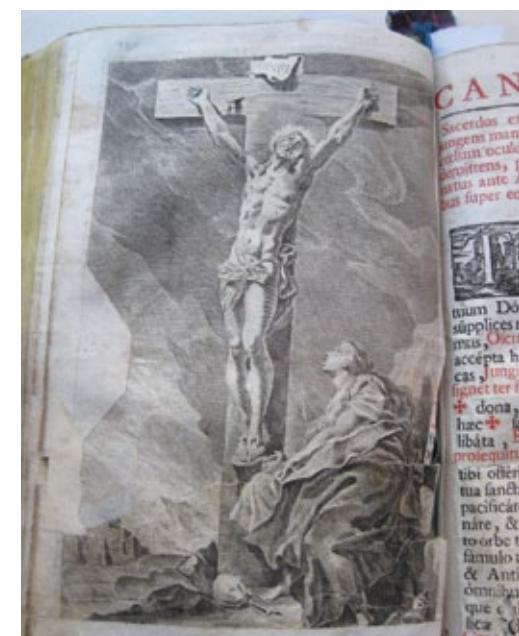
As a result of restoration, this monument of book publishing has recovered its visual qualities; besides the restoration has ensured its further preservation.

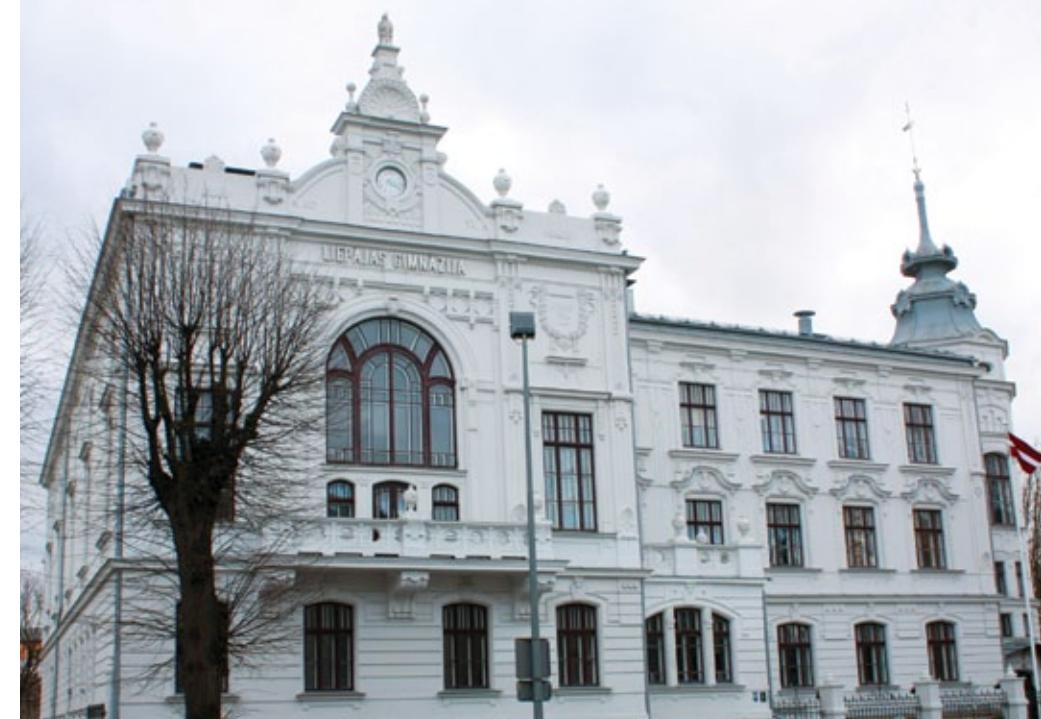
Architect Louis Melville designed the building of Liepāja Grammar School No 1, originally the Liepāja Girls' Grammar School. The construction was completed in 1912. Its miraculous renaissance is surprising not only because of the art nouveau facades and the timeless solemnity of its assembly hall, but also due to the special feeling that something significant has taken place here. The entire building has the unfading strong ambiance of the school loved by many generations. The school has undergone a comprehensive technical modernisation, however, without extremes, while its architecture and historical environment have been preserved. One cannot get rid of the impression that the school has always been like this — with slightly worn plank floors, art nouveau windows and doors, paintings by old masters acquired over many generations and the school relics along the corridors. The simple and sincere renovation of Liepāja Grammar School No 1 is a modern and professional proof that the architecture, the art of the building and identity values created by the previous generations are not merely an obsession of a small group of heritage fans, but serious attempts to recreate the space with deep understanding and care.

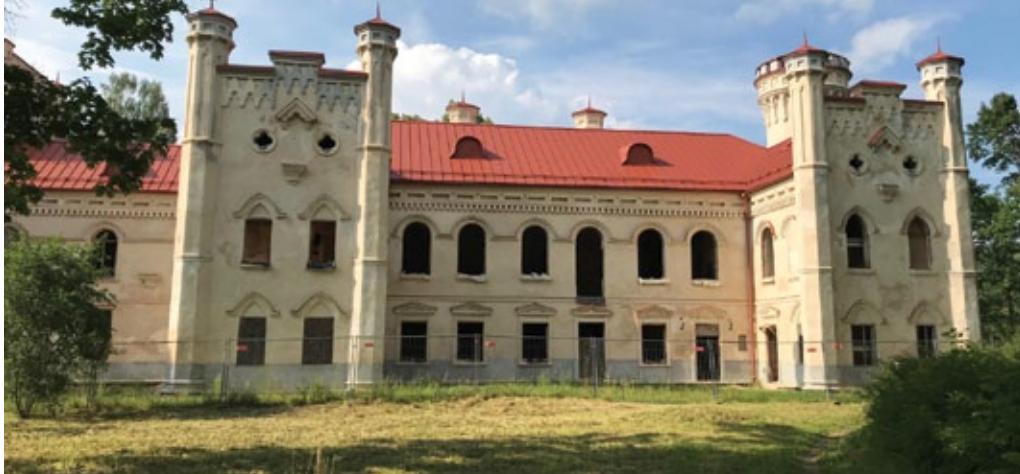
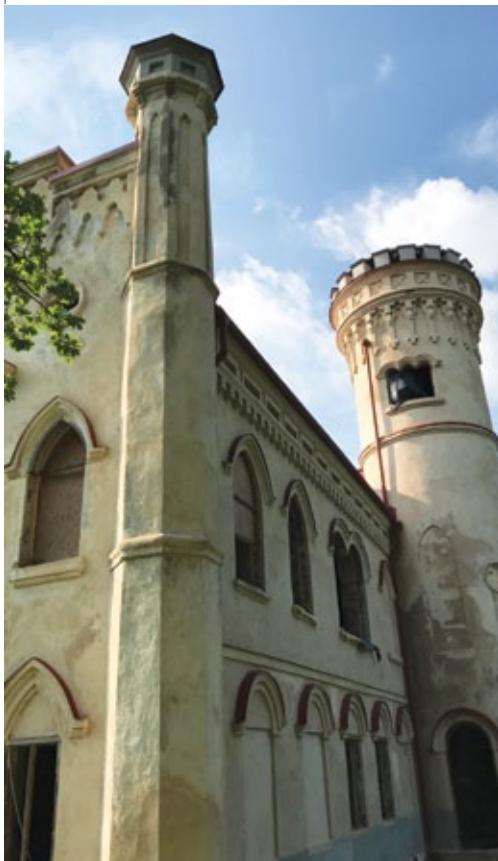
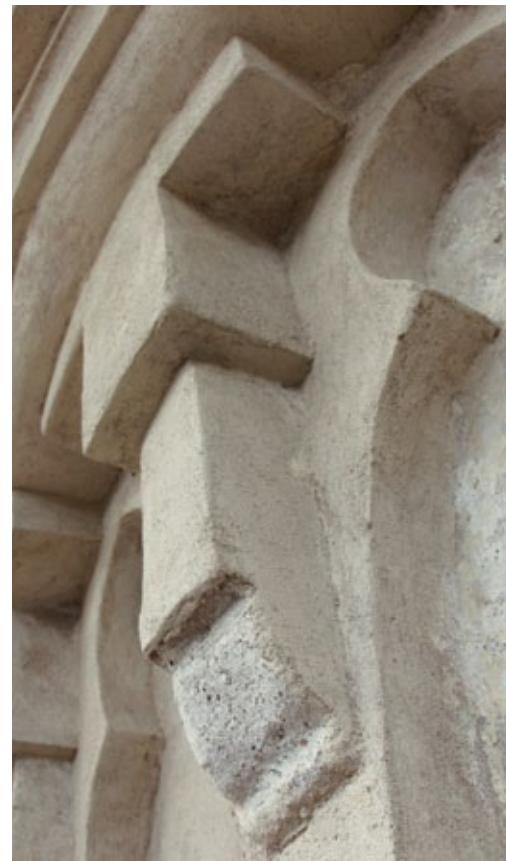
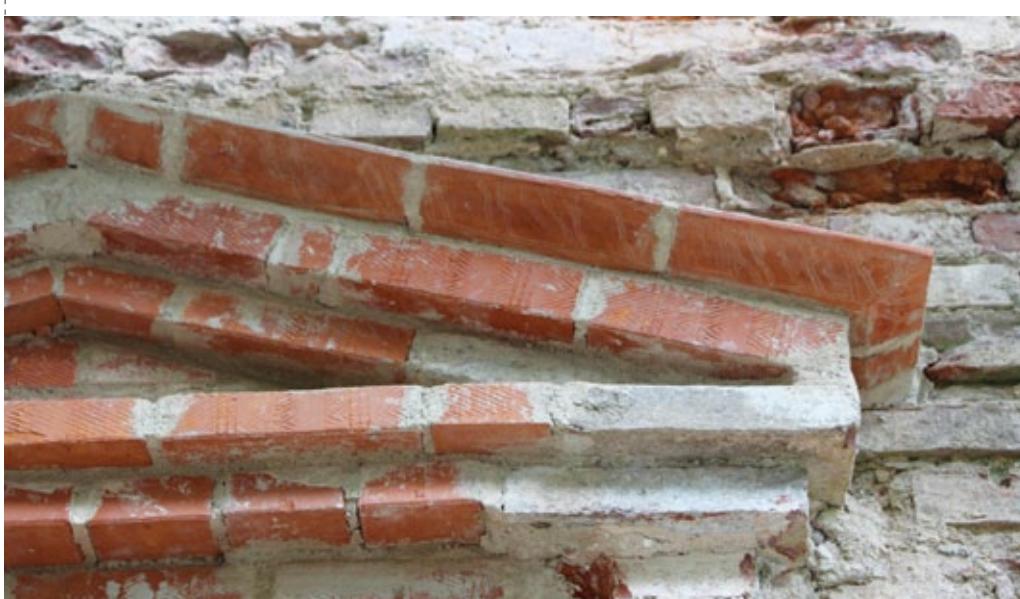
For 500 years (from 1382 to 1882) the town of Preiļi was owned by the Count Borch's family. A chapel for the Borch's family was built in 1817. The construction of the new palace and the modification of the park by expanding its surface area were started in the 19th century. Preiļi Palace is an outstanding example of manor architecture from the era of Latgale historicism (Neo-gothic Eclecticism). The fire of 1978 destroyed the upper part of the building and since then the palace has gradually turned into seemingly hopeless ruins. The heritage professionals asked to carry out urgent palace conservation works; however, their voices were not heard. Nevertheless, thanks to the measures taken by the Preiļi Municipality Council, in 2016 the rebirth of the palace in terms of its architectural appearance was initiated. Phase I of the renovation of the palace was completed in 2017 and included the renovation of the facade, roof and porch. The heritage community was impressed by the fast improvement of the palace achieved through restoration works by the local construction company. Initial concerns regarding the lack of experience and competence were erased by careful and responsible work carried out by the local craftsmen, as well as by their understanding of the historically used traditional materials, technologies (they used lime plaster mix that corresponds to the original in terms of its content) and the concept of authenticity.

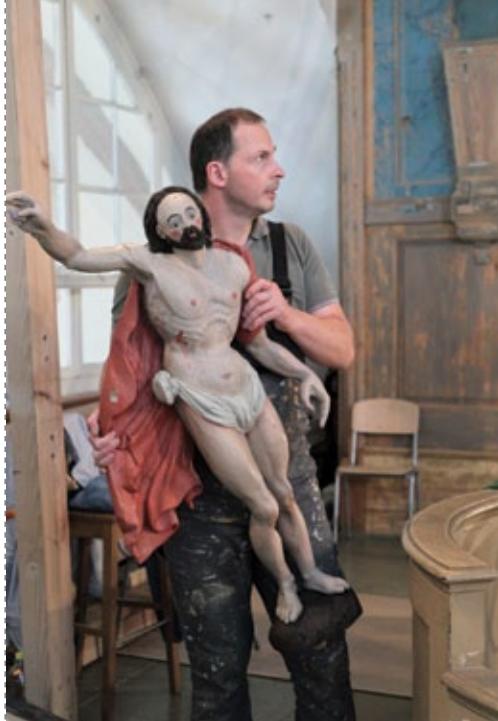
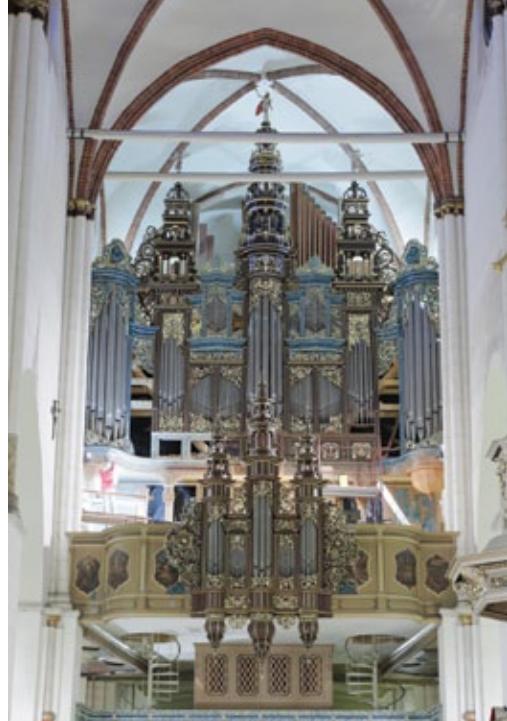
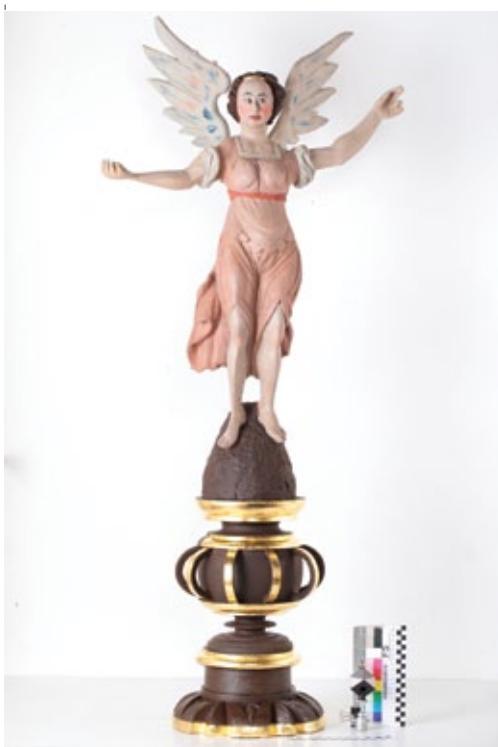
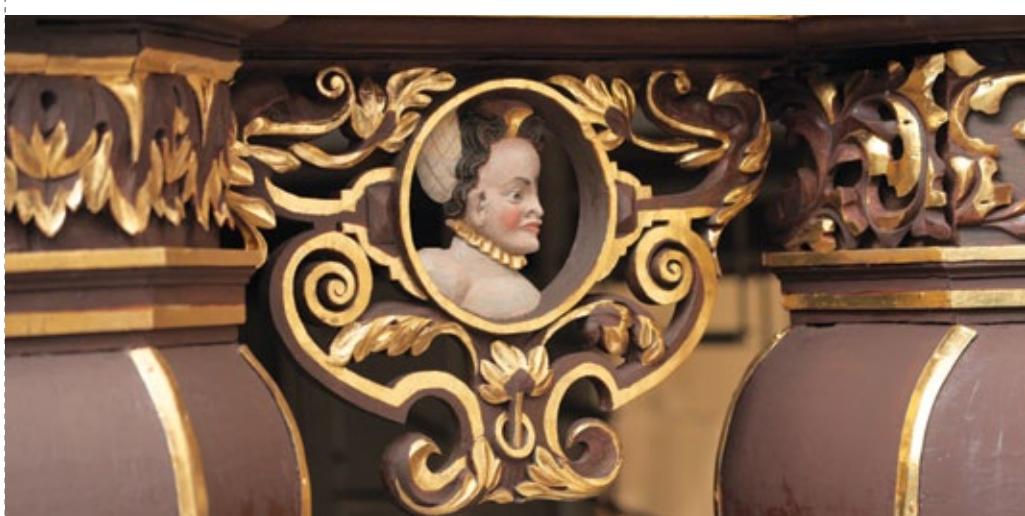
The need to restore the case of the Riga Cathedral organ was identified
already back in 1999 when mould and dirt were found in the organ
chamber. The wood carvings had been glued together using chippings
and other materials, and the case structure was unstable. The oldest
part of the case was created in 1601. Originally, the instrument
console was designed as a cabinet with an opening front part. In the
18th century, the case was modernised by adding acanthus wings in a
Baroque style (this composition has been preserved in the case of the
small or the so-called positive organ) and, after enlarging the organ,
pipe bundles were added with Rococo decor along the sides of the
case. Over the centuries, some individual wood carvings or their
fragments have been customised and fixed, also by changing their
painting.

During restoration, the construction of the case was stabilised and
the decorative wood carvings were fixed and cleaned down to the
original paint. This work of art has never looked the way it looks
now – the golden casing allows the viewer to appreciate the fantasies
of Mannerism, the azure euphoria of Rococo and the explicit twines
of Baroque acanthi. The valuable layers made over the period of
400 years have been preserved. The discoveries made during the
restoration are outlined in a scholarly publication.

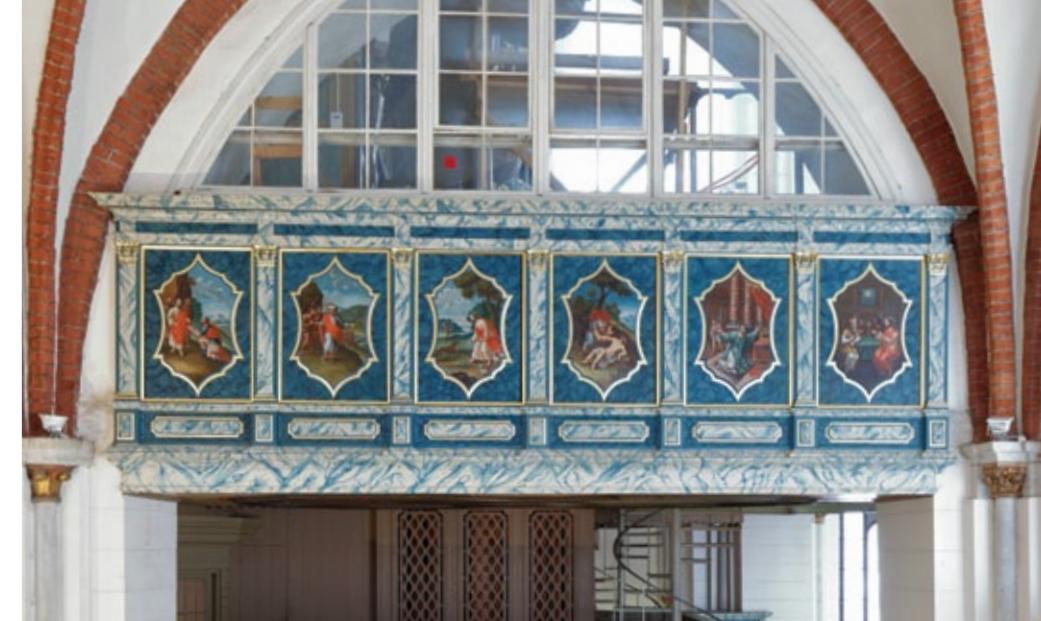
The balconies or galleries at the west end of the church that are decorated with paintings were built around 1738. Intensive restoration work took place at the church from 2 November to 22 December 2017. All together, 18 panels of the upper balcony with images from the New Testament were restored and the marmorised paint of the railing was revealed. In the course of examination of the paintings, it was found that their composition and the range of colours form one ensemble, however, the differences in the depiction of human figures and faces indicate that there might have been several authors contributing. During the last (undated) restoration, the paintings were covered with a new layer of lacquer and subjected to minor additions in places where the paint layer had disappeared. As in the earlier restorations, the task was to clean the surfaces from dirt, as well as to consolidate the paint layer and cover it with a new protective layer without trying to improve the technological imperfections (wrinkles and gaps in the paint layer) that have developed during the process of painting. Furthermore, it was agreed to perform shading only in places of mechanical losses, thus ensuring that the work of art has a great visual appearance and can be viewed as a seamless whole with the entire decorative composition of the west end of the church.

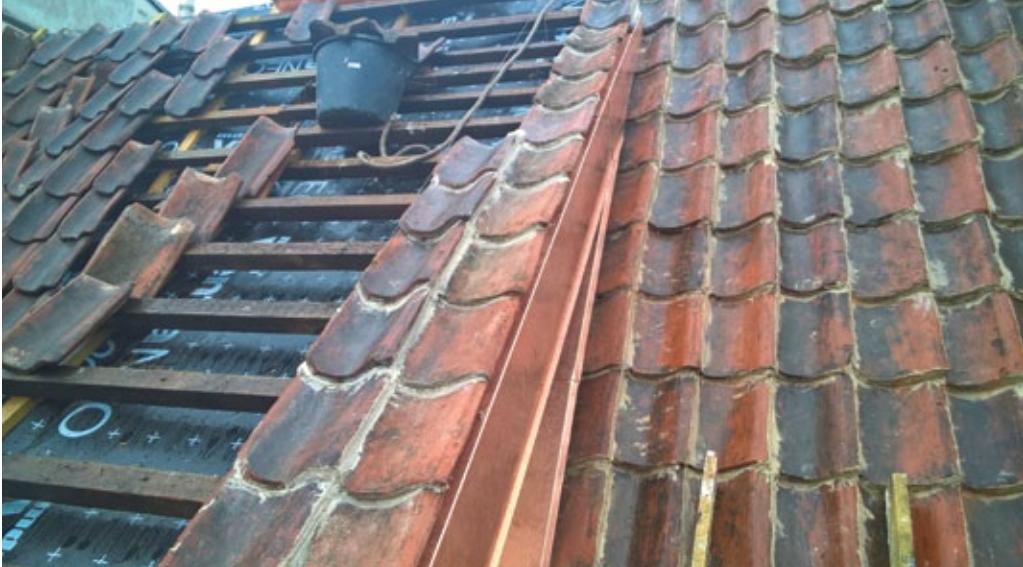
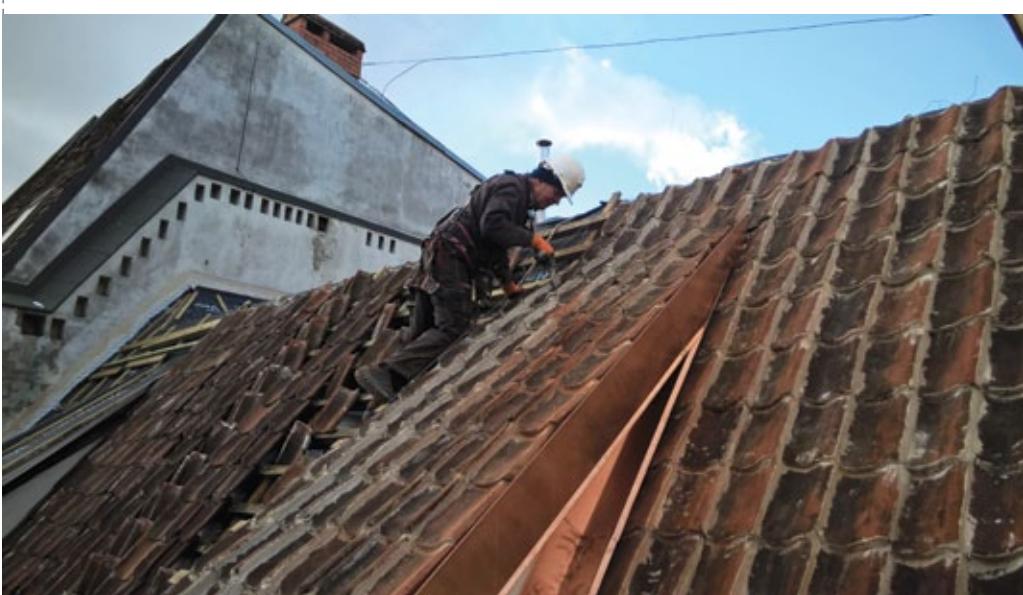
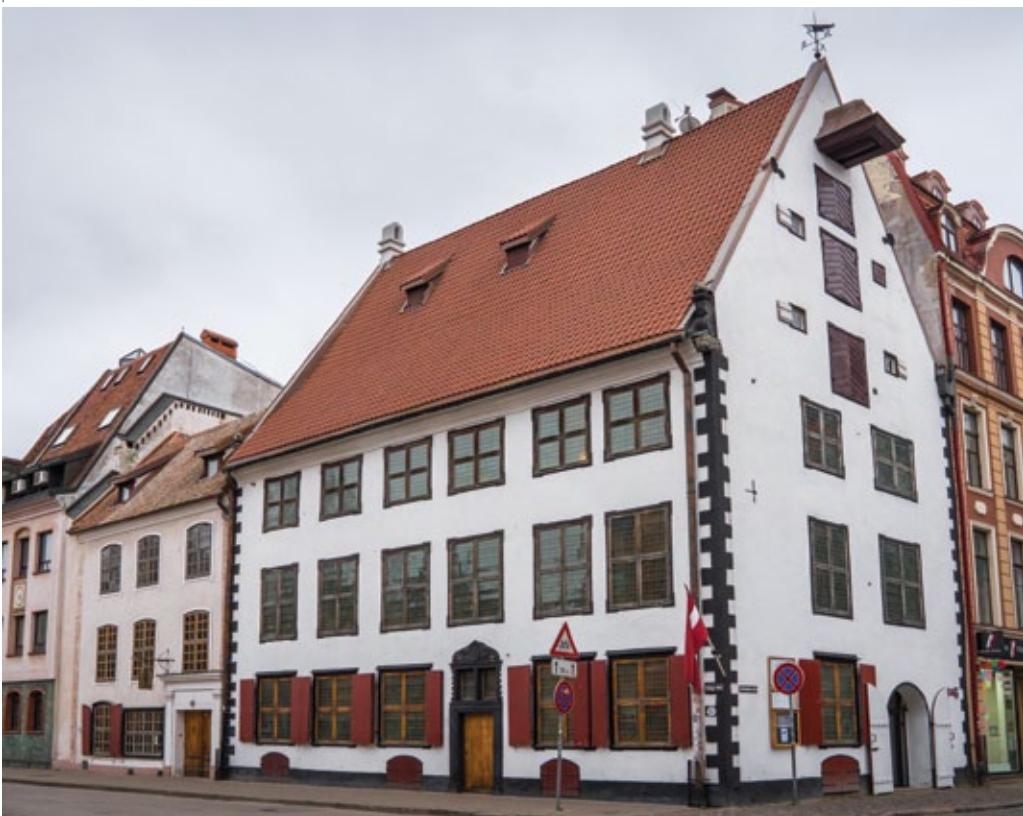
In the early 1990s, during the restoration of the building, the roof of the Mentzendorff's House (the 17th–18th century dwelling house), particularly the streetside part of the roof covering of the three-storey block, was installed with several types of the 18th–19th century S-type clay tiles collected from other sites in Old Riga creating a unique collection of such a type in Riga. Unfortunately, since the restoration (works from 1987 to 1992 were performed by Polish company PKZ) numerous tiles have been damaged beyond repair and lost. Due to the defects of the roof covering and connections, and because of the delayed repair work an extensive renovation was required.

When restoring the roof covering, the historical tiles — upon request by the experts of the National Heritage Board — were reused for the third time. Now they cover the streetside part of the roof of the museum, or the so-called Small house. Since the tiles were not similar and did not fit precisely, the tile gaps were sealed with lime mortar. We are delighted to see that, although unproven reinforced mortar materials were used, this initially unintended task was executed in good quality. It is the only example of the clay tile roof covering of such a type in Riga.

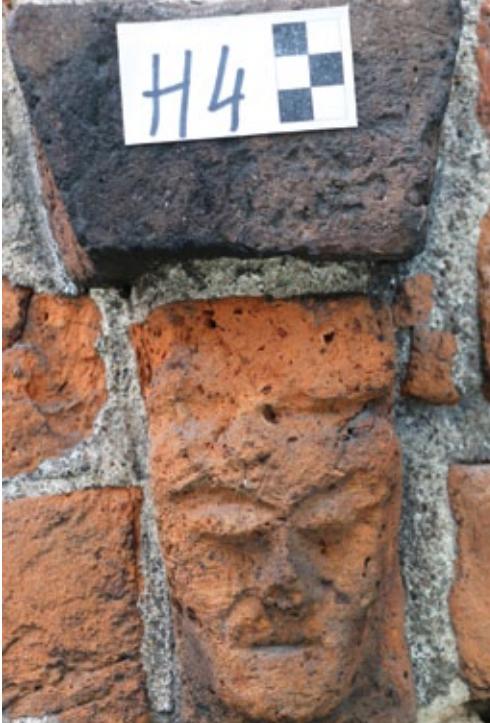
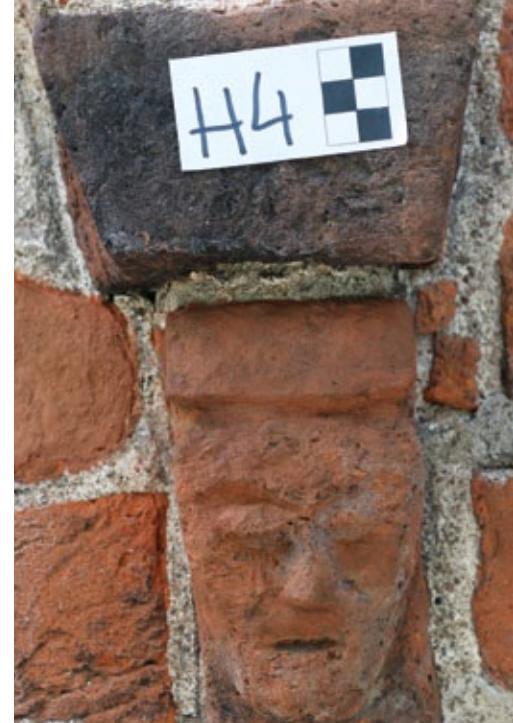
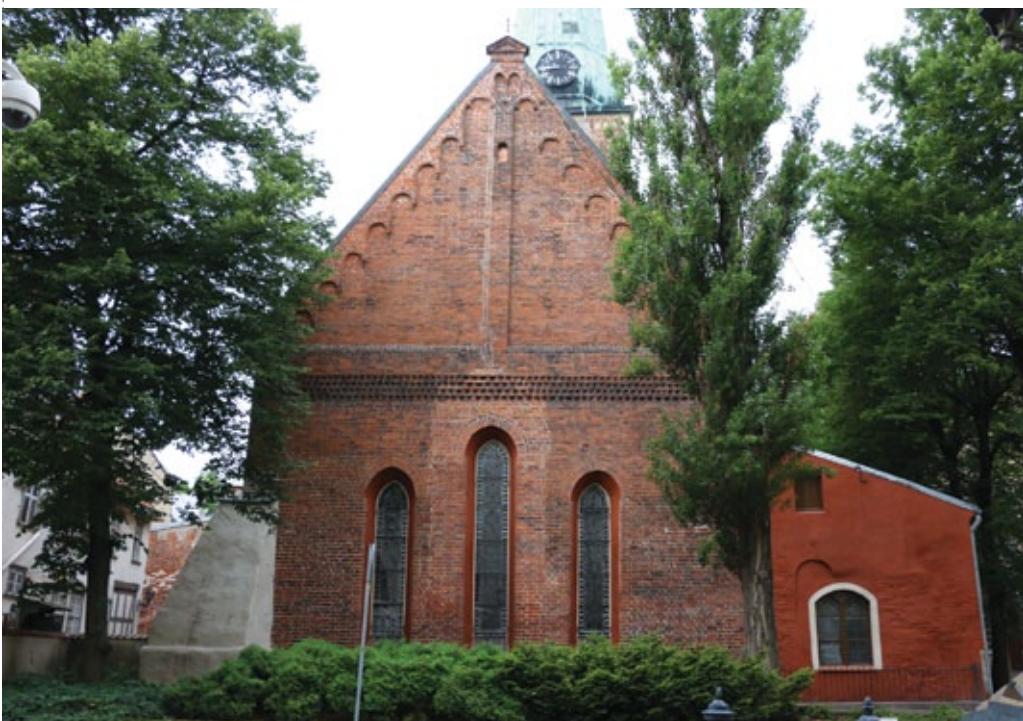
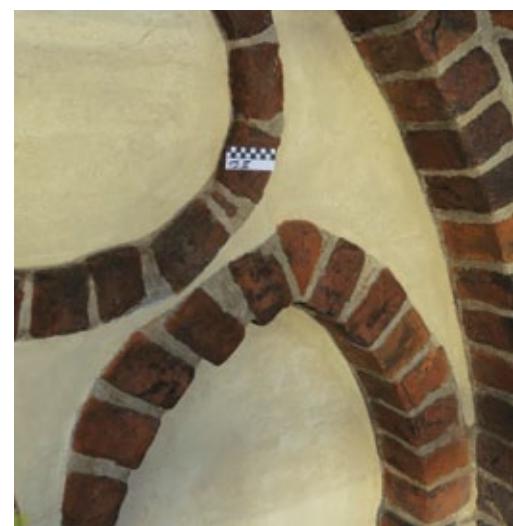
Overall, the technical condition of the facades can be described as good. In places the loss of the surface of the base material can be observed. There is also surface detachment and pulverization, as well as surface darkening and crumbling along the plaster seams noticeable. The goal of the restoration was to stop erosion of the facades, and to conserve and carry out the facade correction and reconstruction works to the extent necessary to preserve the original appearance as much as possible. The work was carried out based on close assessment of the historical value of each layer. There were extensive discussions about the solutions that could be the most appropriate for a building of such a high historical and sacral profile. As a result of the restoration work, the building has acquired a convincing overall visual appearance that shows evidence of the complicated and long construction history of the building.

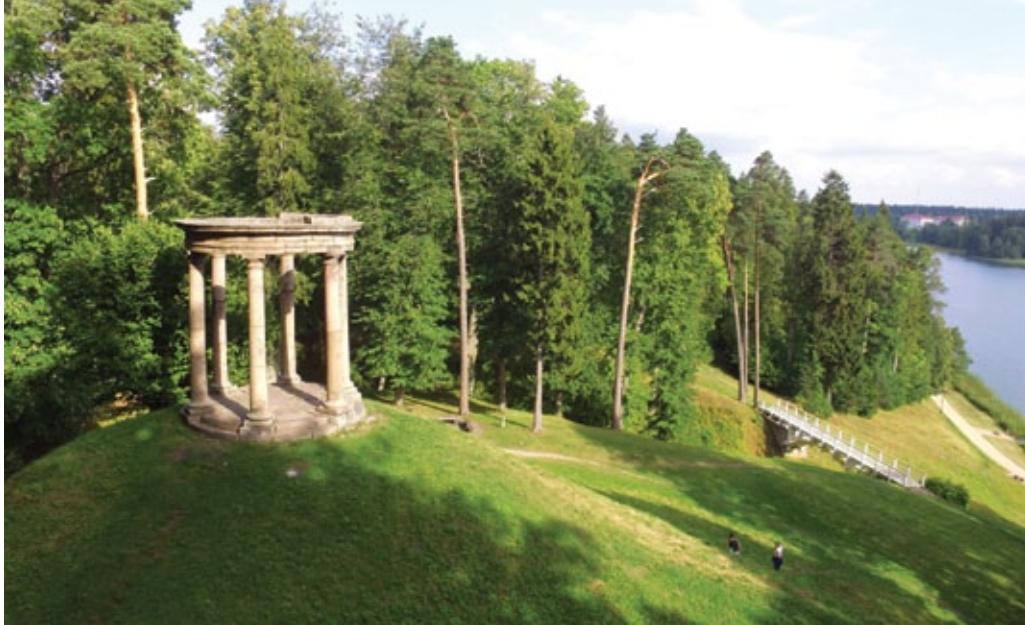
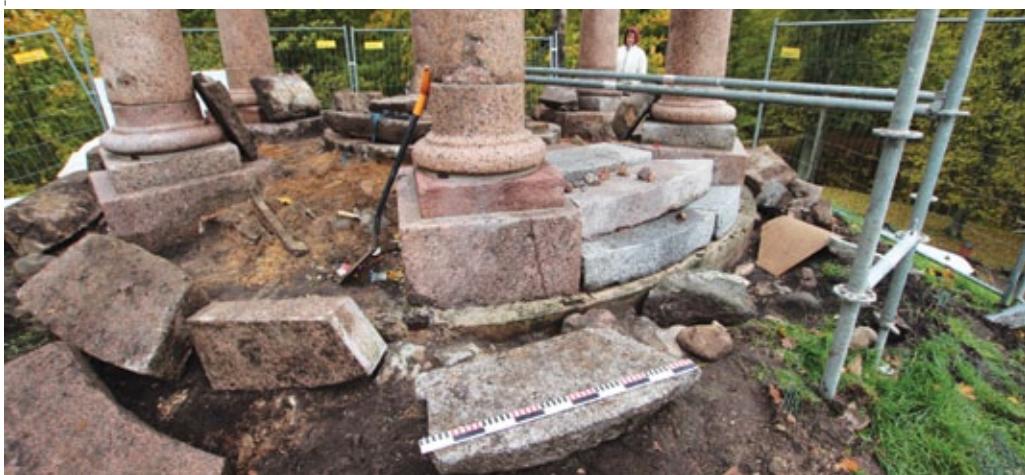
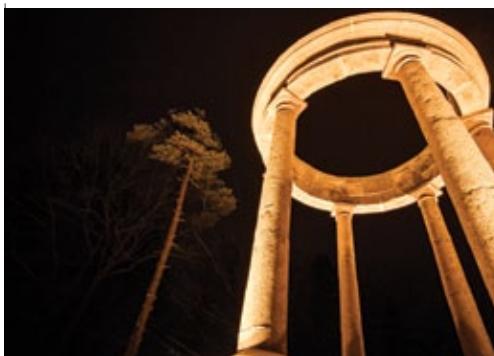
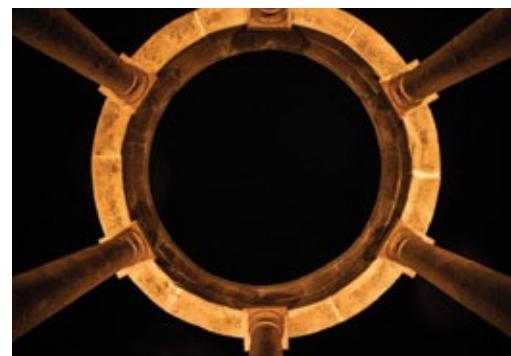
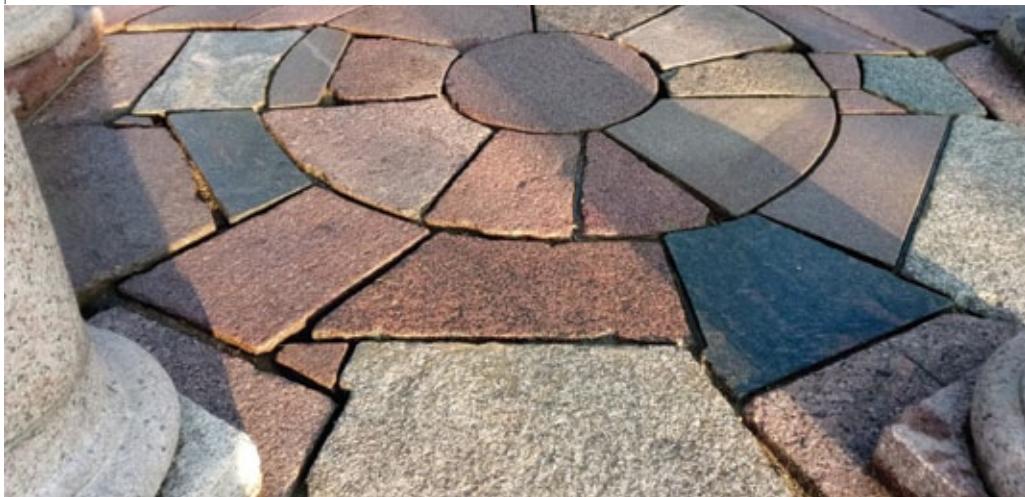
The Alūksne Manor Park with all its park constructions and rich landscape is an outstanding cultural value of Latvia. The Vietinghoff family, who were the owners of the estate, promoted the creation of the park for almost a century. The park reflects the trends of garden art of the second half of the 18th century and the 19th century, and it is unique for its large area and the integrity of the entire composition. One of the landmarks in the park landscape is the Temple Hill, a historical Latgalian hillfort where Baron von Vietinghoff in 1807 commissioned the construction of a granite rotunda to commemorate the events of the Northern War that took place in the territory of the modern-day Latvia. Affected by time and weather, the granite elements of the rotunda were deformed that could have led to the collapse of the structure. The restoration was challenging; however, the restoration specialists succeeded in levelling out the deformations, stabilising the construction system and filling the seams of granite elements. By following the authenticity preservation principles the rotunda was restored preserving the original substance as much as possible. Thanks to the efforts made by the municipality, a number of park constructions have been restored, and the town's greenest landmark looks well maintained.

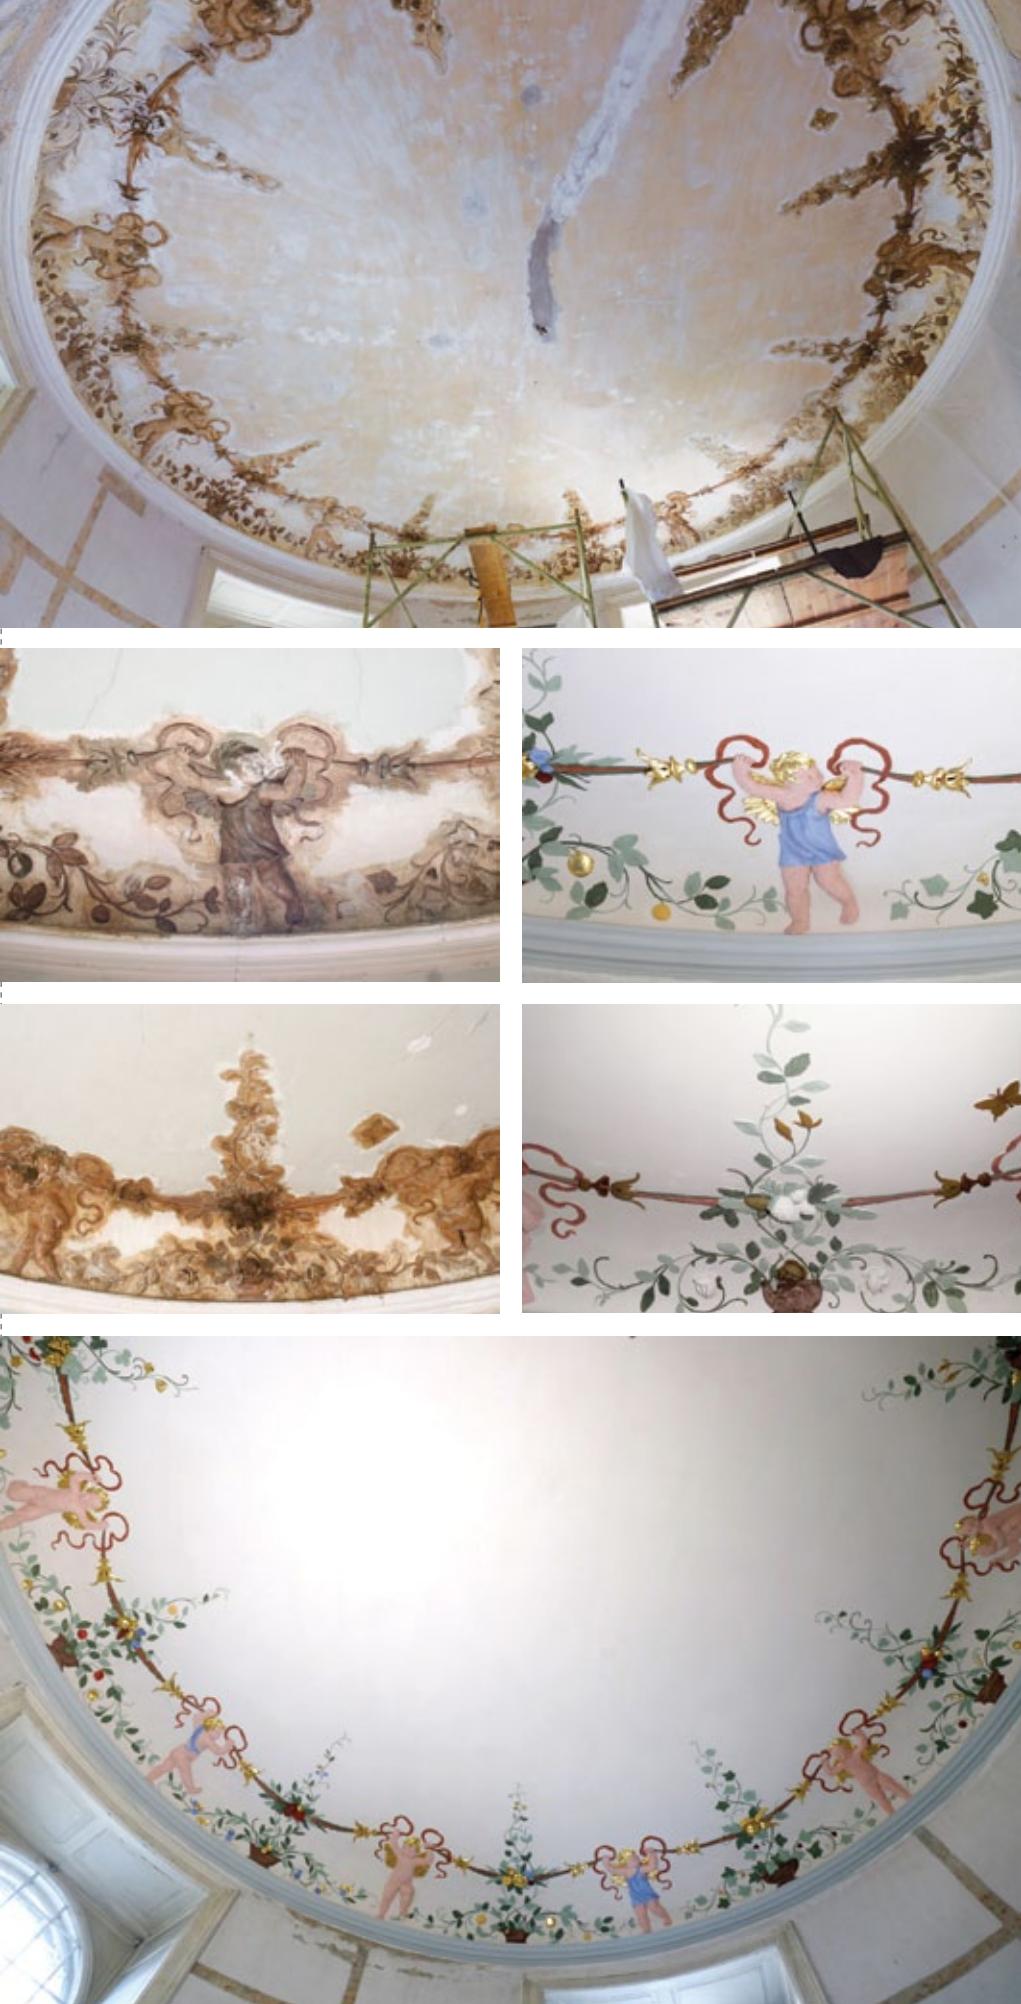
During the restoration, the ceiling mouldings were cleaned, the layers of the previous low quality restorations were removed, the stucco mouldings were restored and the missing pieces were reconstructed. Furthermore, the smooth surface of cornices and ceiling, and the decorative paint were restored. The methodology developed and the materials used in the restoration process will serve as an example for further restoration work.

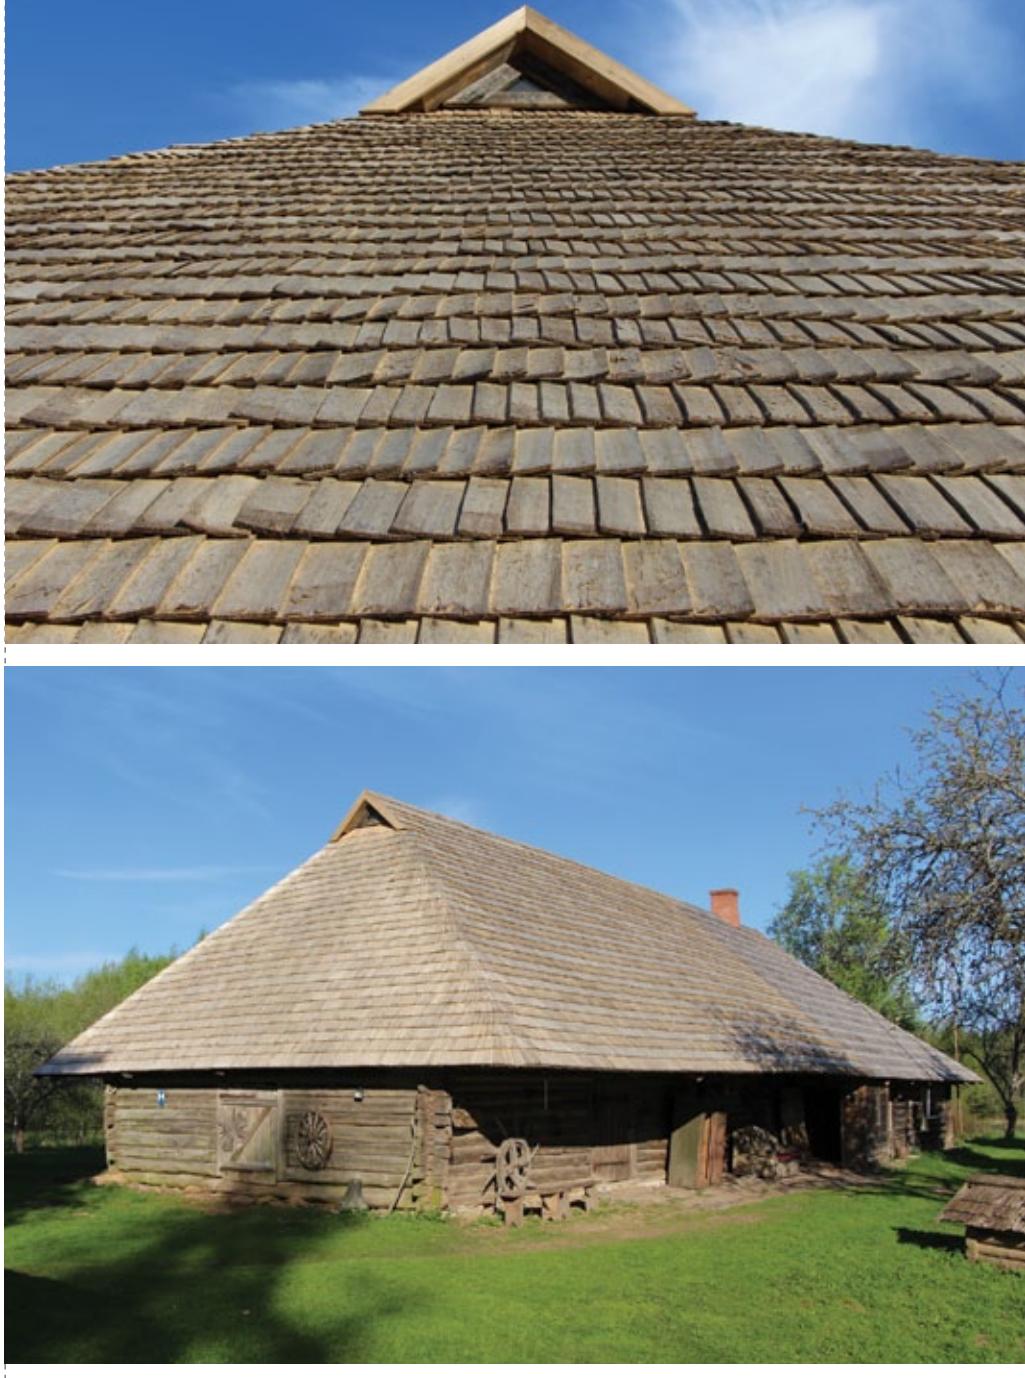
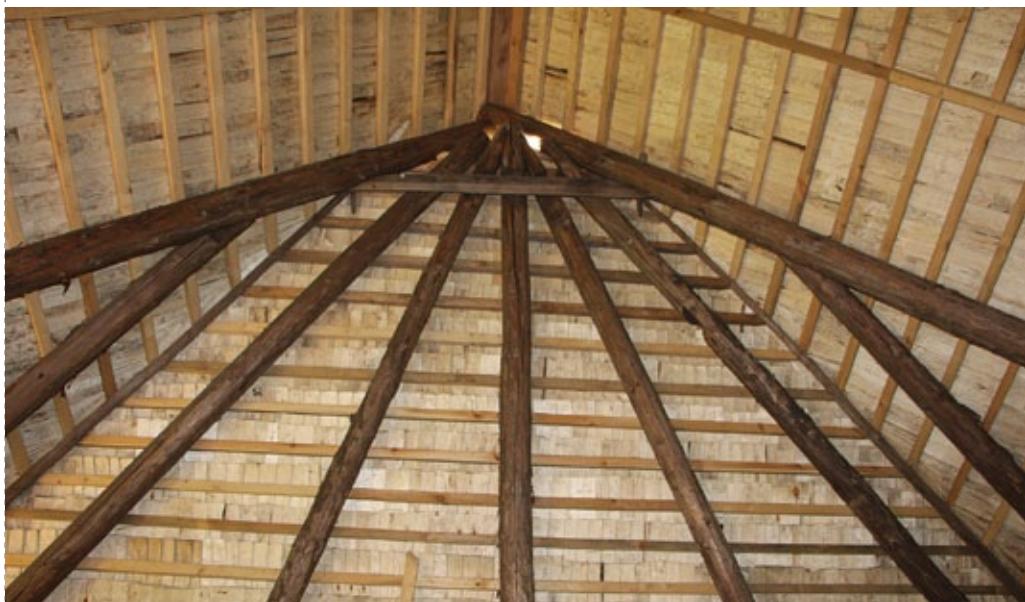
ROOF REPLACEMENT OF THE THRESHING BARN AT SĒLEŅI FARMSTEAD
