**RESTAURĒTIE
KULTŪRAS
PIEMINEKĻI
LATVIJĀ
2017**

**RESTORED
CULTURAL
MONUMENTS
IN LATVIA**

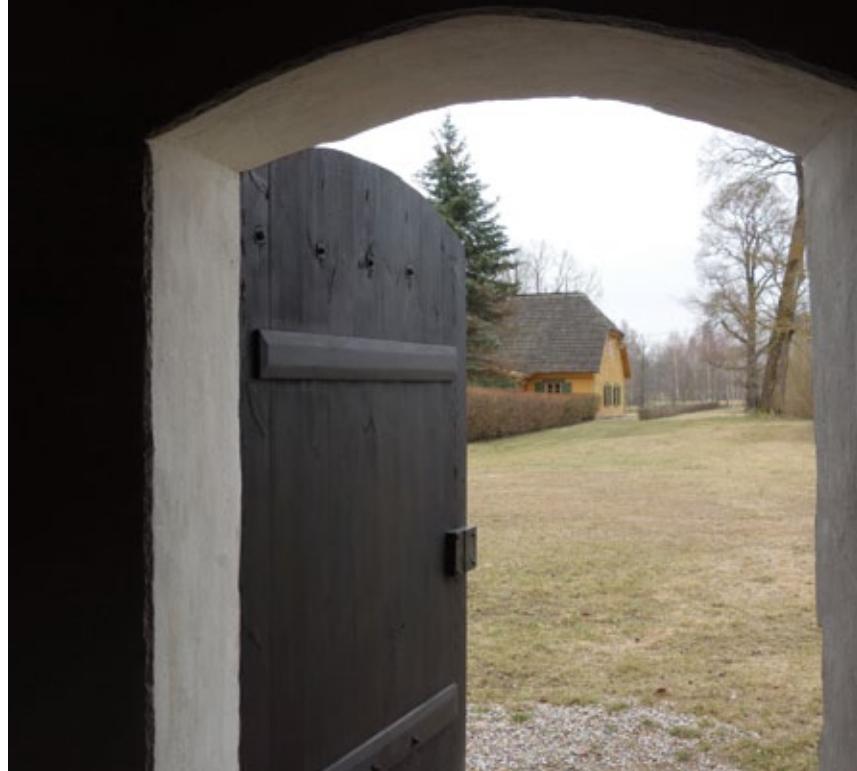
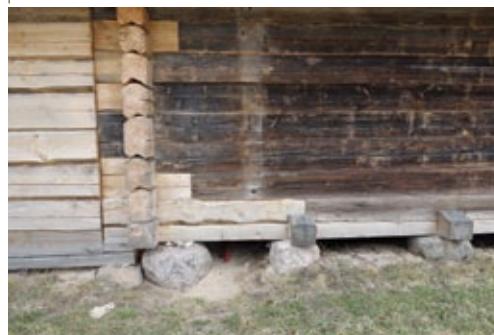
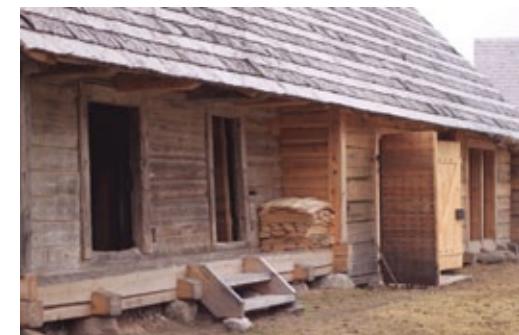
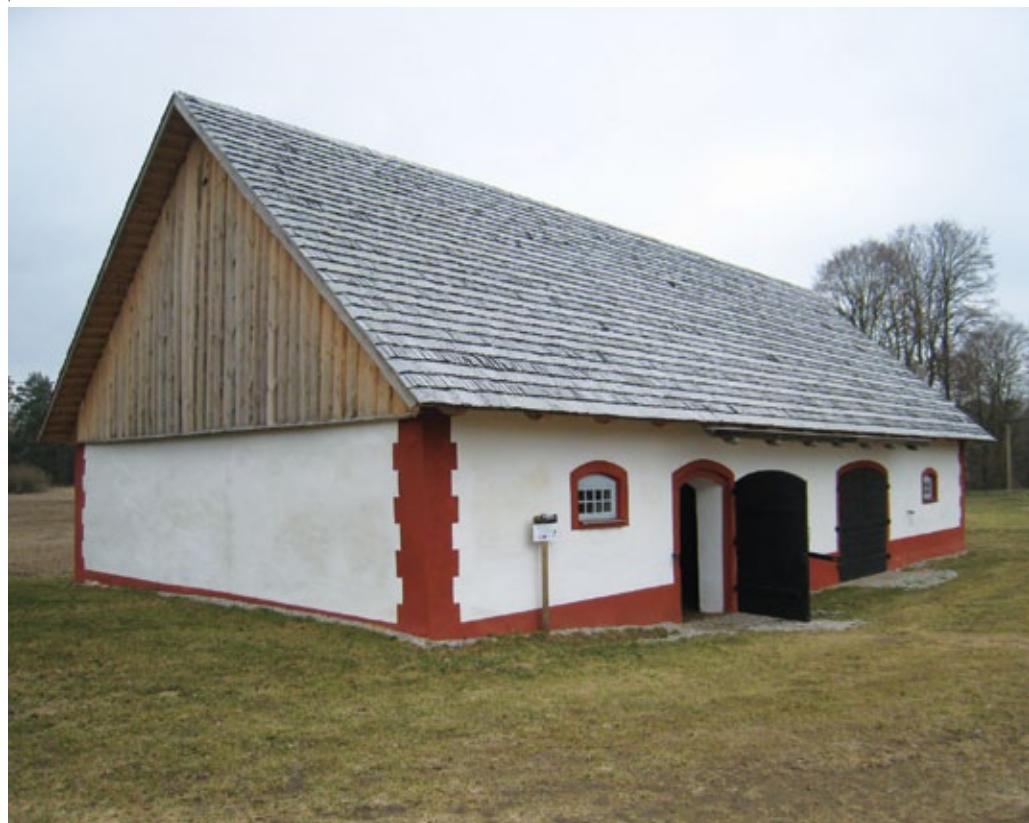
The Vilis Plūdonis Museum at his childhood home *Lejenieki* was founded in 1936. *Lejenieki* is an old farmstead traditional to the historical region of Zemgale. The barn and the shippon were in a critical condition; during the soviet times they had lost part of their construction volume and were poorly repaired. In 2013, research was carried out aimed at identifying the original substance and elaborating a restoration plan. The barn was reconstructed in its original appearance starting off with overall disassembling of the building and afterwards moving it to the workshop where the damaged elements were fixed. The building was given back its original arrangement and the doorway casements and windows. Moreover, the floors and overheads were restored. The roof construction was built anew based on precise data acquired through research. Similar actions were also taken in the restoration of the shippon, although it is a stone building. The rural household utensils are exhibited in the barn, while the shippon is offered for viewing as a carriage house. The *Lejenieki* farmstead has recovered two significant elements of its complex – the barn and the carriage house – allowing to fully appreciate this significant cultural value in Latvia.

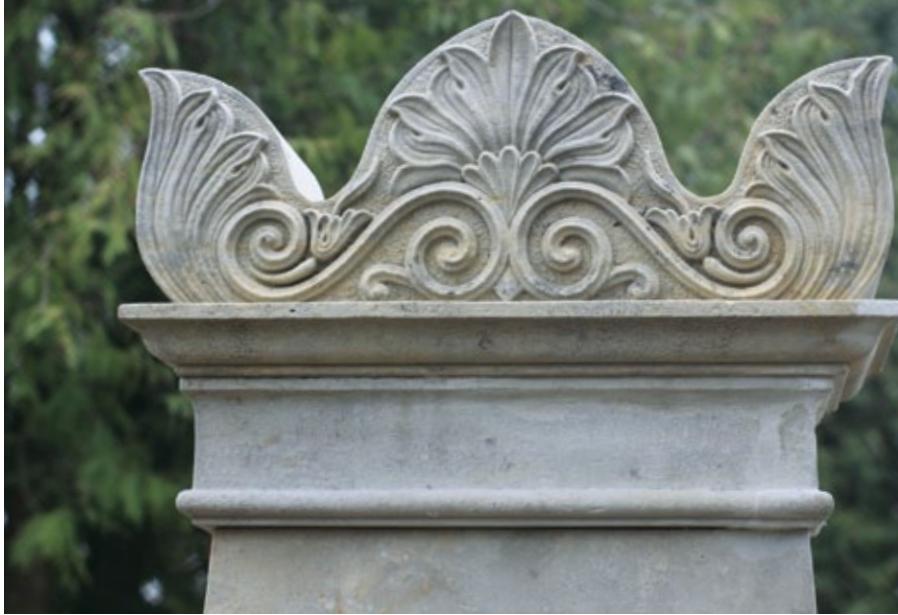
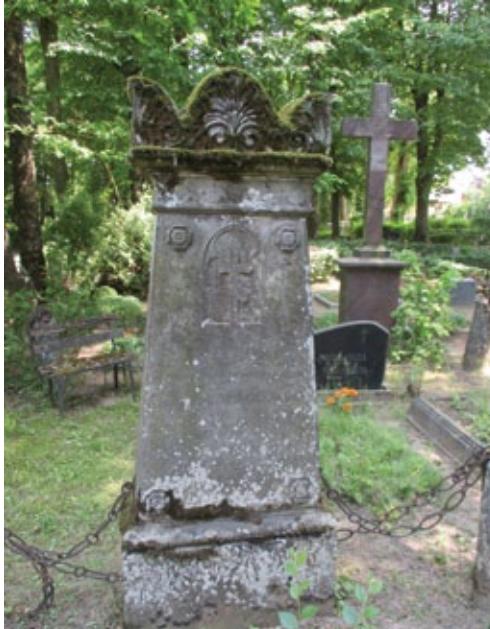
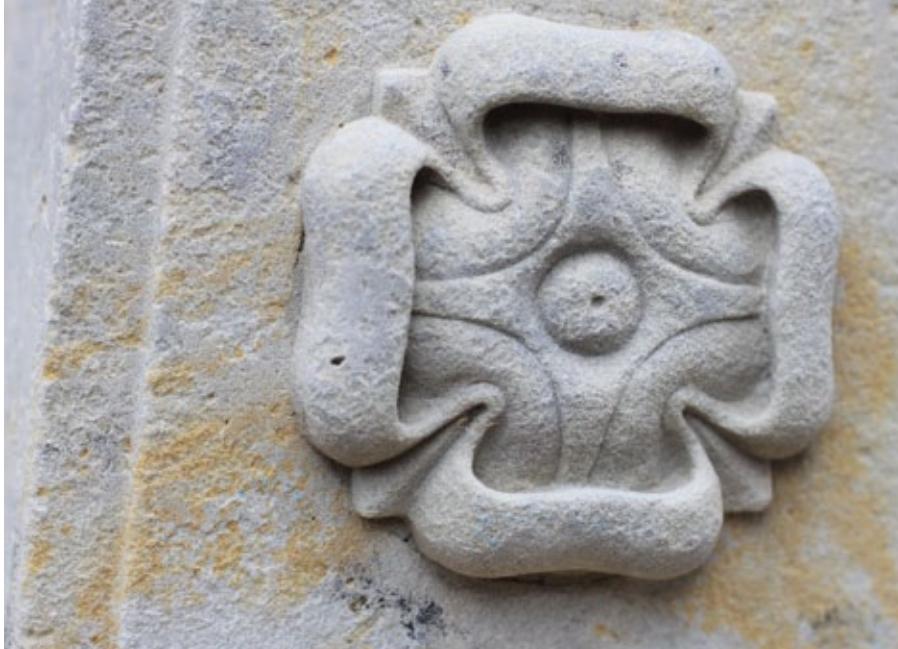
The gravestone has been repaired before fixing minor detachments and reconstructing the toppled top part, however, in an unprofessional manner. Over time, the surface has become covered with moss, algae and grass, and damaged in several places; the top part has moved aside. During restoration, the gravestone was cleaned mechanically and using pressure washing. Stone fractures and cracks were sealed using mortar, but in the larger areas that have been lost a copper armature wire was installed. Artificial sandstone mortar was used to reconstruct the lost pieces. Furthermore, the places of earlier repairs were retouched and the surface of the gravestone was treated with a growth prevention material.

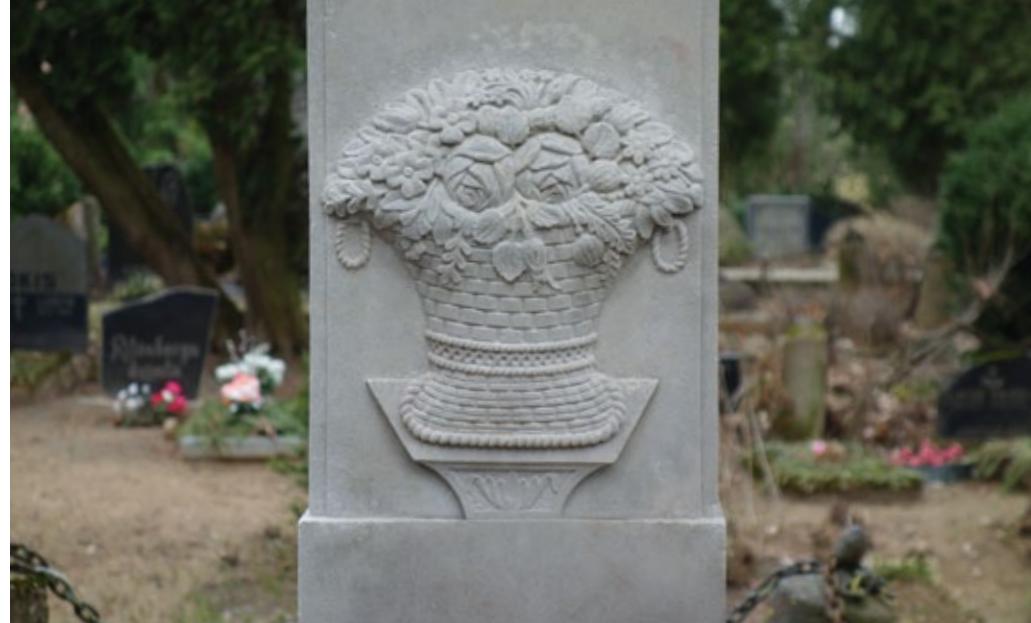
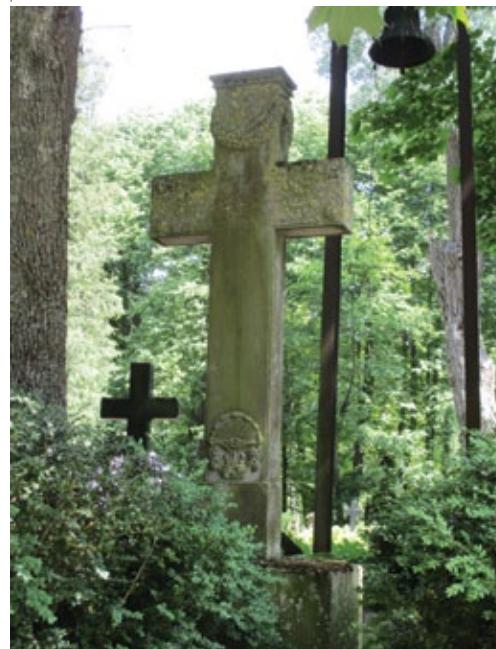
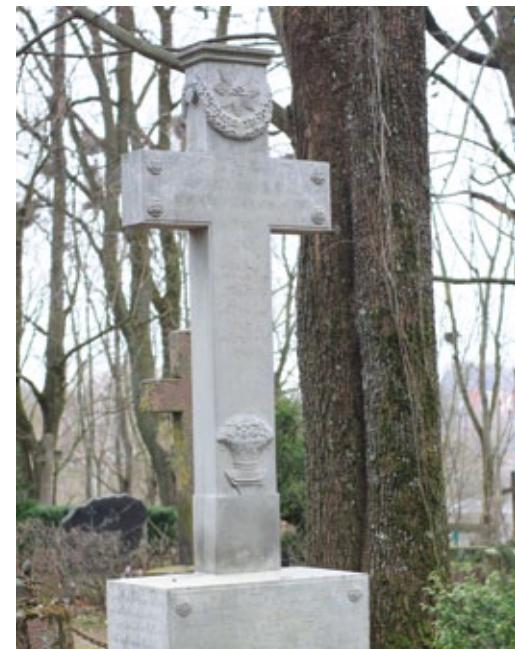
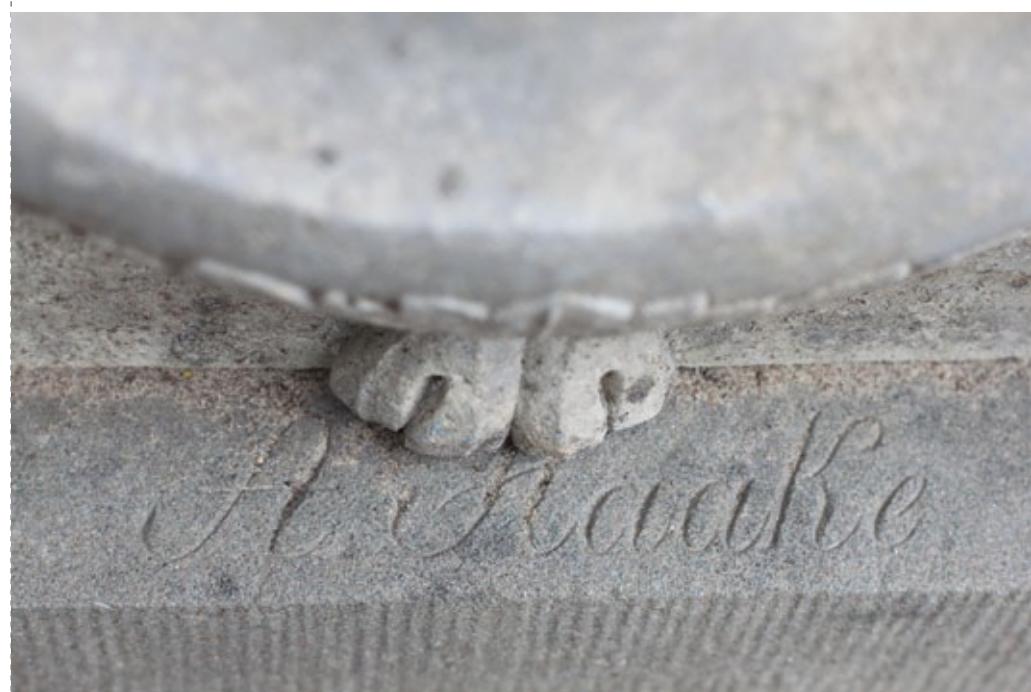
The gravestone has already been repaired earlier. Before restoration, the gravestone was covered in algae, lichen and moss causing surface damage. Furthermore, in the area between the cross and the foundation a gap had appeared. During restoration, the gravestone was cleaned mechanically and using pressure washing. The split near the foundation was sealed with silicone sealant. The surface of the gravestone was treated with a growth prevention material.
